# **National Register of Historic Places Registration Form**

Boulder Point Lookout

Other: "Readicut" L-4 Lookout House

Boulder Point Lookout is an excellent example of the 1931-patten L-4 Lookout House, originally designed by Clyde Fickes. It is located roughly two miles northwest of the West Fork Ranger Station—the administrative headquarters of the West Fork District. The only access to the lookout is from a two-mile-long pack trail. The lookout structure is located atop a narrow rocky prominence known as Boulder Point (elevation 7,753 ft.) on the ridge that extends southeastward from Boulder Peak, about two and a half miles to the northwest. This ridge line serves as the boundary of the Selway Bitterroot Wilderness Area. Boulder Point itself is a rocky prominence, with a nearly vertical drop-off on its north side into the Boulder Creek drainage. Vegetation in and around the lookout consists of mixed stands of Douglas fir, subalpine fir, and lodge pole pine. The lookout commands a view of the Boulder Creek drainage to the north (including the south side of Trapper Peak) and the Nez Perce / West Fork Bitterroot River confluence to the south.

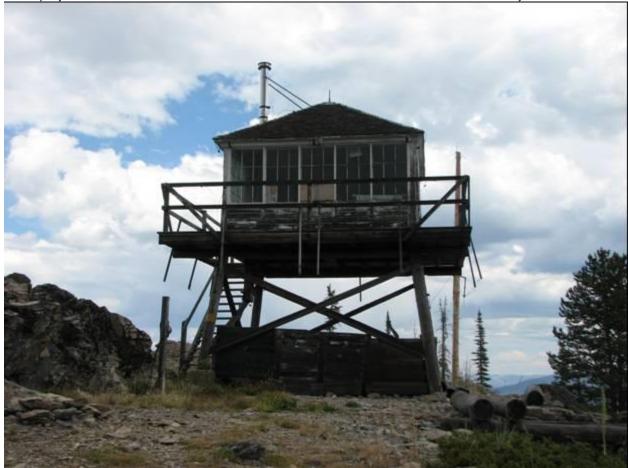
MT\_RavalliCounty\_BoulderPointLookout\_0001. Looking east to the west wall of the lookout.

The property possesses integrity of location, setting, materials, workmanship, design, feeling and association. The lookout itself is in good to fair condition, with a few missing/damaged glass panes in its west wall windows and openings. While the shutters have been removed from some of the windows (the west wall and half of the north wall), they remain on site. Besides the lookout, the site area contains a wood frame outhouse, in fair condition. The outhouse door has been repaired with plywood.

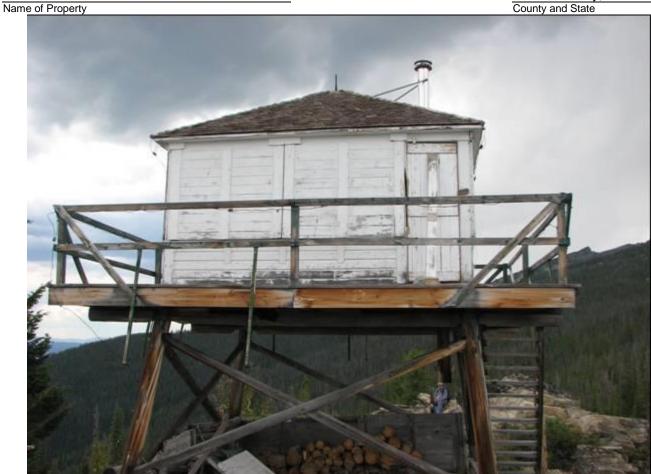
MT\_RavalliCounty\_BoulderPointLookout\_0002. Looking west to the east (front) wall of the lookout.

The Boulder Point Lookout is a 14 ft. by 14 ft. wood frame building with a pyramidal roof built atop a 10 foot-high, log tower. Simple drop wood siding covers the lower portion of the exterior walls, and the roof is covered with sawn cedar shingles with metal ridge caps. A new stainless steel stove pipe extends above the north slope of the roof. The entry into the lookout house is located at the north end of the east wall, and contains its original six-light wood door; a board-and-batten storm door has been added over the door. Four nine-light windows are located in the wall south of the entry. The remaining three walls each contain five, nine-light, wood windows, two of which slide sideways allowing ventilation. Several panes of glass are missing from the west wall windows—the openings filled with cardboard and/or wood. The window shutters on the west wall and the east half of the north wall have been removed, but remain on site. The struts to hold the shutters remain fixed to the lower rail in the catwalk safety railing. The building retains its lightning protection.

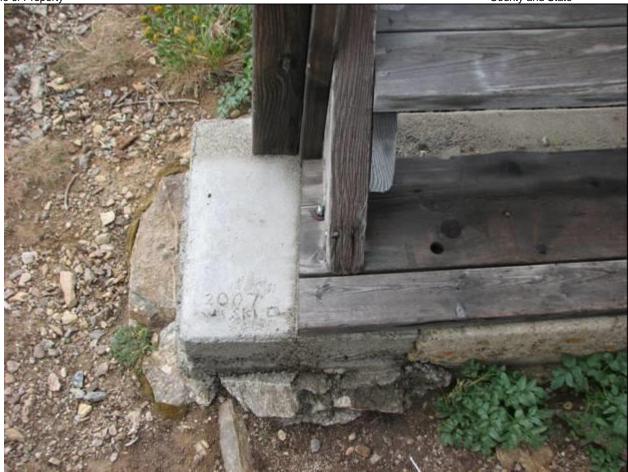
MT\_RavalliCounty\_BoulderPointLookout\_0004. Detail of 2007 concrete footing work done by volunteers.

The four legs of the cross-braced tower have cast-in-place concrete footings. A single-flight stairway leads from the northwest corner of the tower base to the catwalk. The trapdoor that would have originally been lowered to secure the tower is missing. The stairs have log stringers and board treads.

Between 2005 and 2007, volunteers from the West Fork Ski Club and forest employees stabilized the lookout. Work included replacing the tower cross beans and legs, re-shingling the roof, repairing and painting the shutters, and installing a new stove pipe.<sup>5</sup>

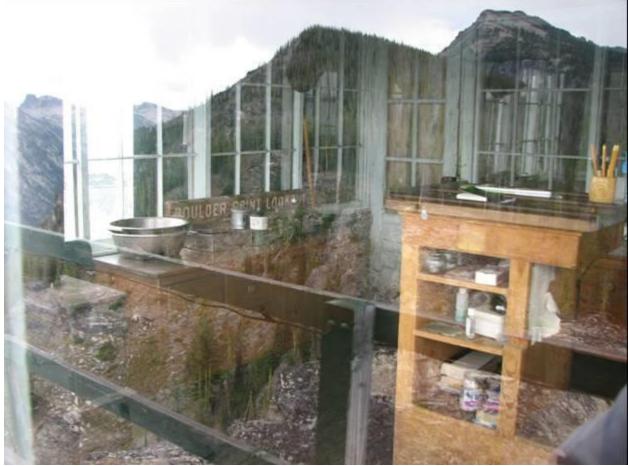
MT\_RavalliCounty\_BoulderPointLookout\_0005. Interior view of the cab. Note the original door at the north end of the east wall.

In the one-room interior, the original maple floor is intact and in fair condition. The space is fitted with a small wood-burning stove, a platform bed with drawers beneath for storage, and several tables, storage benches, and a wood box.

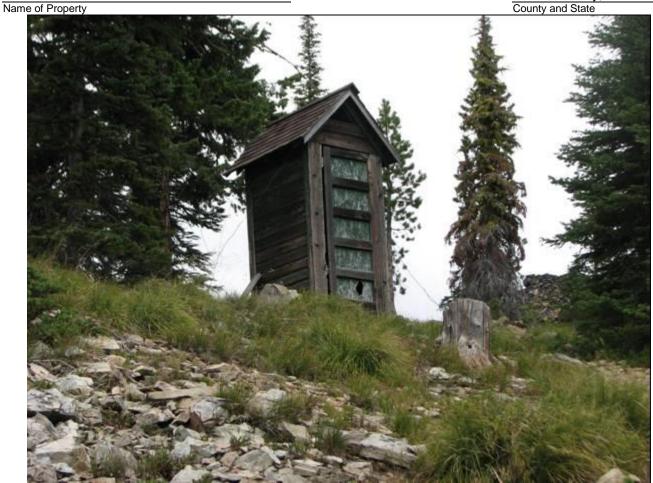
MT\_RavalliCounty\_BoulderPointLookout\_0006. Looking northeast to the west and south (front) walls of the outhouse.

The outhouse is located about 200 feet east of the lookout. This one-story front-gable building measures 3.5 ft. by 4 ft. Stones are piled around the base of the building, which is also guy-wired to the ground. The exterior walls are covered with simple drop wood siding with vertical corner board trim and a diagonal brace on the rear (north) wall. The wood shingle roof appears to be new. The front (south) wall has a five-panel wood door. Although the door appears to be original, its original wood panels have been replaced with plywood.
